AC NO: AC 20-76
DATE: 21 Oct 71

MAINTENANCE INSPECTION NOTES FOR BOEING B-707/720 SERIES AIRCRAFT

**DEPARTMENT OF TRANSPORTATION
FEDERAL AVIATION ADMINISTRATION**

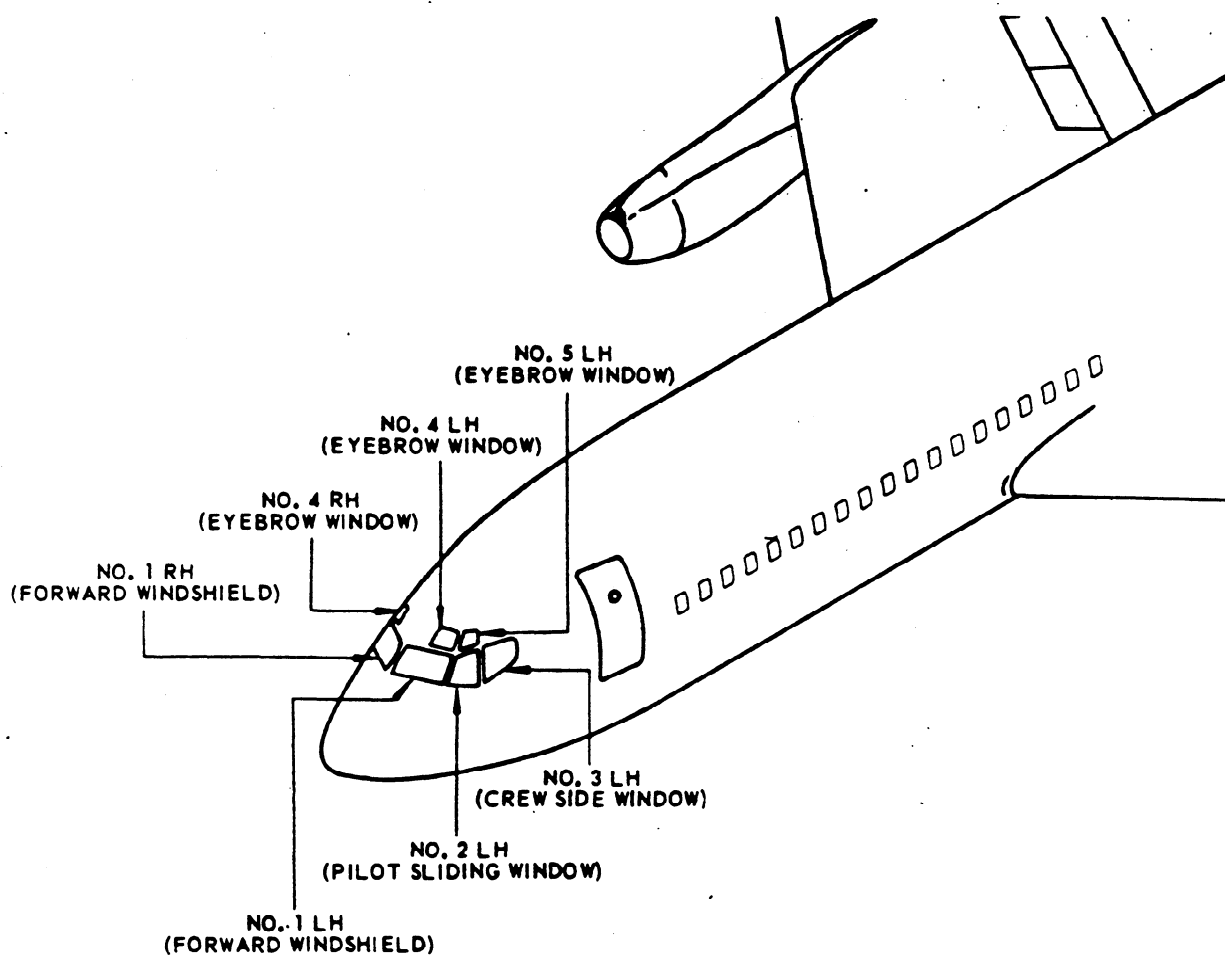
FIGURE 1. CONTROL CABIN WINDOW LOCATIONS

- a. Control Cabin Windows (5). The control cabin windows (1 through 5) consist of a thick transparent vinyl plastic core sandwiched between an inner and outer tempered glass layer. On the inboard face of Number 4 window, there is an additional vinyl core and a layer of acrylic sheet. Sliding windows are in Number 2 window position. The other windows are stationary and bolted to the airframe. (See Figure 1).

- (c) Loose or missing window frame fasteners.
 - (d) Rain repellency of windows.
- (2) Scatched Windows.
- (a) Inner pane scratched. Inner pane scratches may contribute to a window failure under cabin pressure and heat.

- (b) Outer pane scratched. Scratches on the outer pane reduces pane strength under normal cabin pressurization conditions. Any scratch causes stress concentration.

- (3) Cracked panes. Any window with a cracked pane should be replaced.
 - (a) Inner pane cracked. This pane takes pressurization load and the airplane should not be pressurized if this pane is cracked.

- (b) Outer pane cracked. Cracks that extend toward the center of the pane or span the pane usually become progressively worse and the pane should be replaced at the first opportunity.

- (c) Cracking of vinyl usually occurs in the upper aft corner of the No. 1 windshields. It is a fail-safe, bird-proof core. The window should be replaced at the first opportunity.

- (4) Delamination. A delamination is the separation of either pane of glass from the vinyl core. When minor delamination occurs between the inner or outer pane and the vinyl core, the airplane could be flown pressurized. An electrically heated window need not be replaced due to delaminations unless the visibility is restricted or lack of window heating, or the pane is scorched.

- (5) Chipping. Chips on the laminated surface of the glass are layers or flakes of glass broken from a surface by excessive stresses. Presence of glass chips on laminated surface should be reason enough for window replacement if airplane is to be pressurized.

- (6) Arcing. Arcing will produce hot spots with possible eventual result of a cracked pane.
- b. Passenger Cabin Windows. These windows are located between the fuselage frames in the areas where passenger seating is provided. Passenger cabin windows consist of outer, center, and inner panes. The outer and inner panes are each capable of taking the full cabin pressurization load. The inner pane is nonstructural. All three panes are acrylic. The emergency exit hatch passenger window installations are very similar to those for the outer and center panes of the other passenger windows. (See Figure 2).

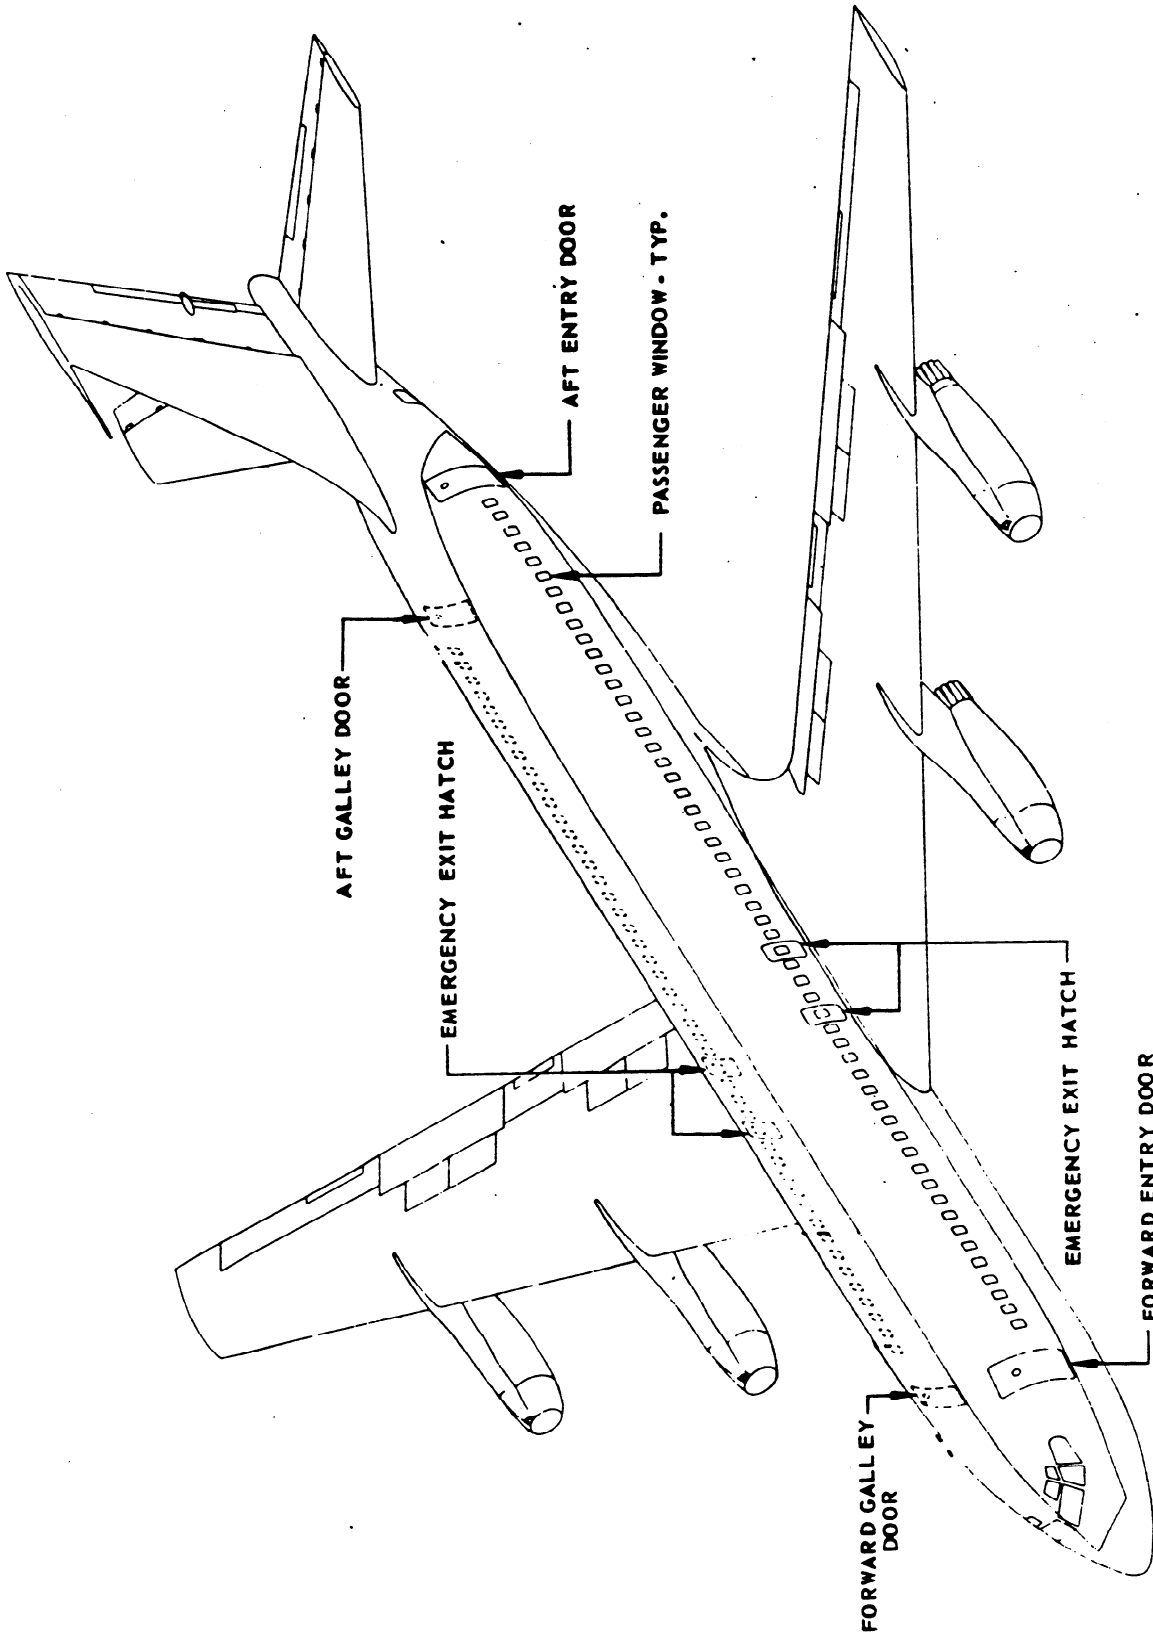
FIGURE 2. PASSENGER CABIN WINDOW LOCATIONS

- (1) Inspection/checks of passenger cabin windows. Examine the window for:
 - (a) Scratches, cracks, and crazing of acrylic panes.
 - (b) Deterioration of seals.

- (c) Marks, Scratches, and dents.
 - (d) Loose or missing fasteners at window retaining brackets.
